AN ARCHITECTURAL STUDY OF SOME LOG STRUCTURES IN THE AREA OF TH--ETC(U)

JUL 78 R C CARLISLE, A FERENCI

huntington district  
u. s. army corps of engineers  
September 1978

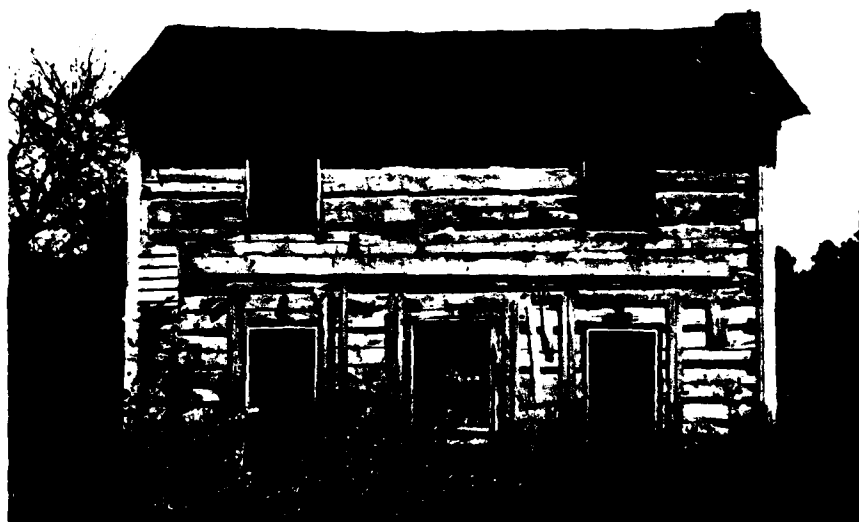
Fig. 21: Main entrance to log home on Tract 239 in southwest wall.  
Note original door width and remnants of frame siding.

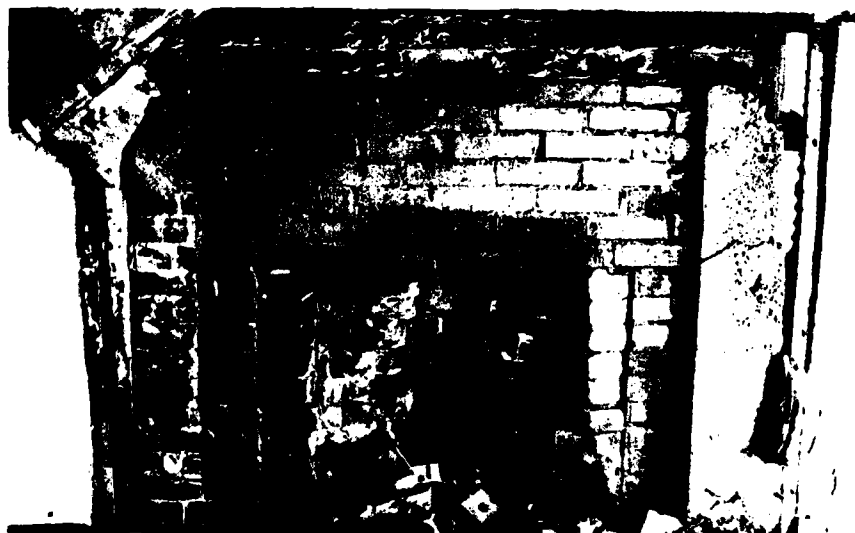
There is one remaining brick fireplace in the structure. This occurs in the southeast wall of Room 1 (Fig. 25). As is evident from Fig. 25 the brick construction matches that of the ca. 1930s chimney and probably replaced an earlier sandstone fireplace. The mortar is entirely of Portland cement and the firebox is arranged in a way to accomodate either a coal grate or gas heater. The overall dimensions of the fireplace are 4'8" in height and 6' in width. The firebox is 2'6" high, 3'1 1/2" wide and only about 6" deep. A second fireplace once existed in Room 3, but the opening was blocked with common planking probably at the time of the construction of the new chimney.

Fig. 25: Fireplace in Room 1 Tract 239. Note shallow depth of firebox.

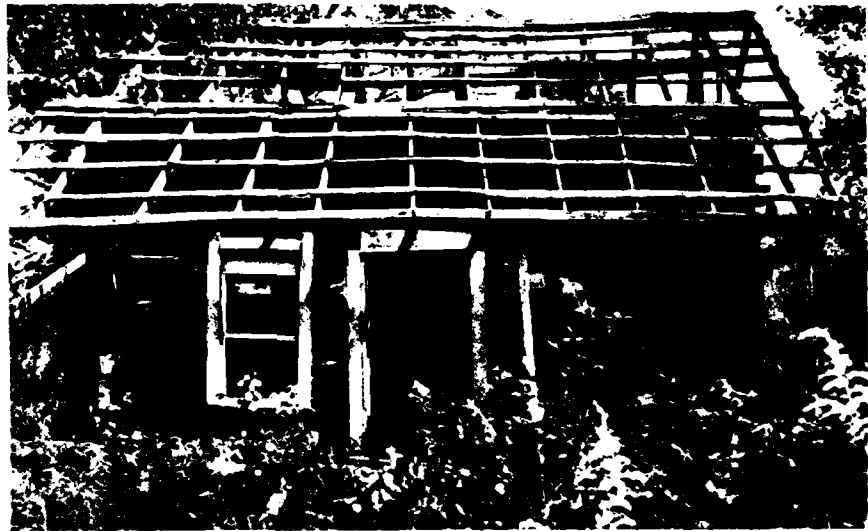
Fig. 29: Entrance in southwestern wall of Building 1, Tract 301. Note method of gable roof construction. Building 2 stands just to the right in this picture.

Approximately 1'8 1/2" to the right of Door 1 and 5' above the porch floor, a carved pair of initials was noted (W). As explained above, subsequent informant testimony identified these initials as those of Willard Adams, a nephew of John Adams, the builder of the dwelling. The surround material on the exterior of Door 1 is variable width common planking ca. 5 1/4" wide painted white. Similar material was used around Window A just to the left of the door (Fig. 29).

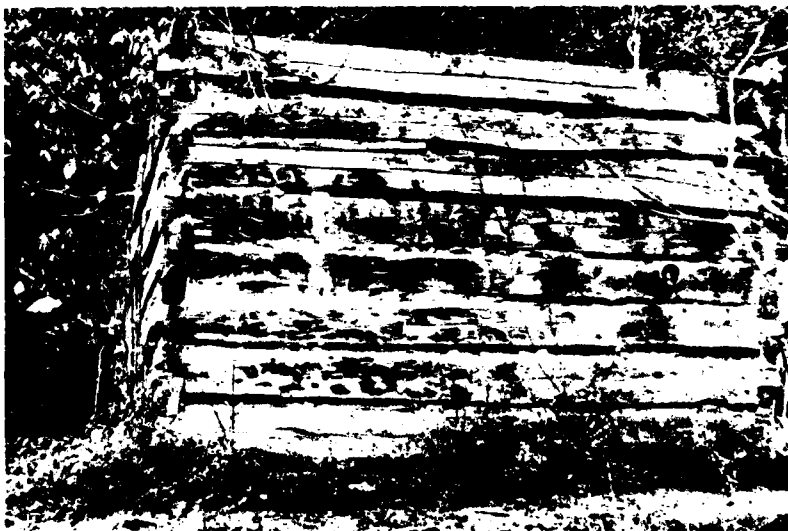
Fig. 47: Northeast wall of southeast cabin, dwelling on Tract 410.

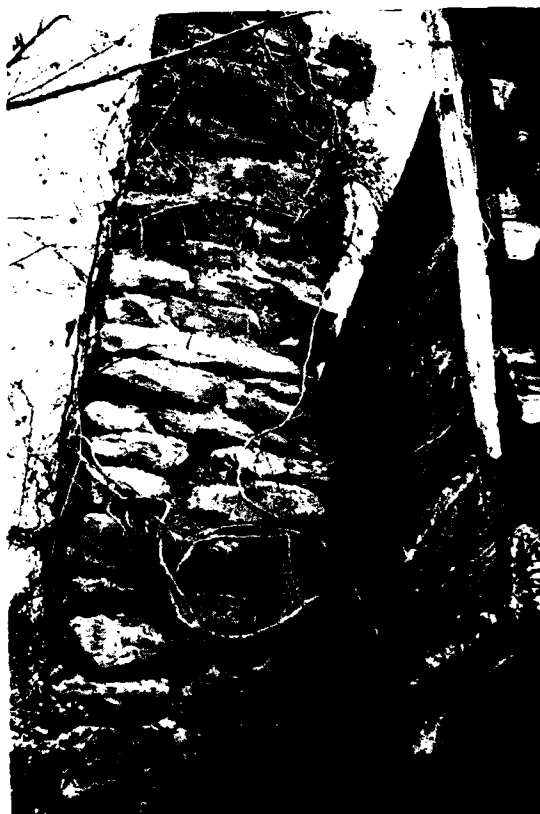
Fig. 48: Sandstone chimney on southwest side of southeast cabin,  
Tract 410.

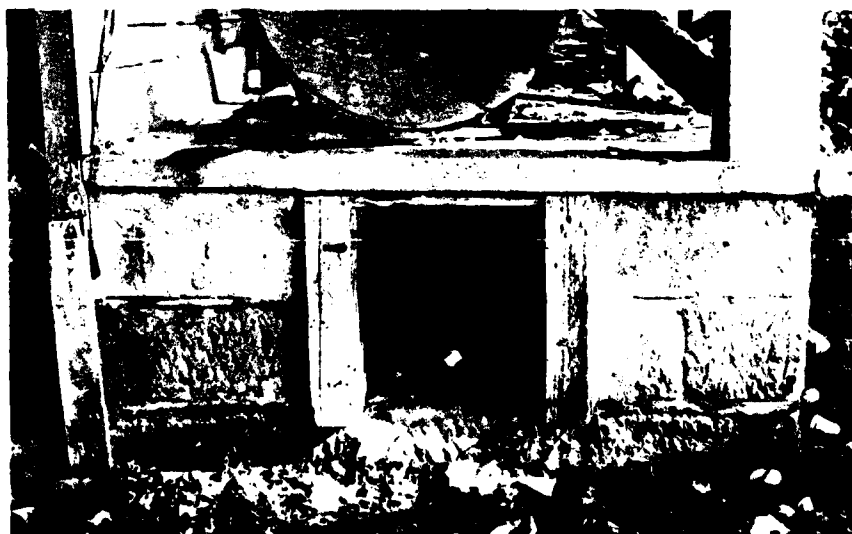
Fig. 53: Detail of cool box or pet pen beneath porch, Building 1, Tract 411.

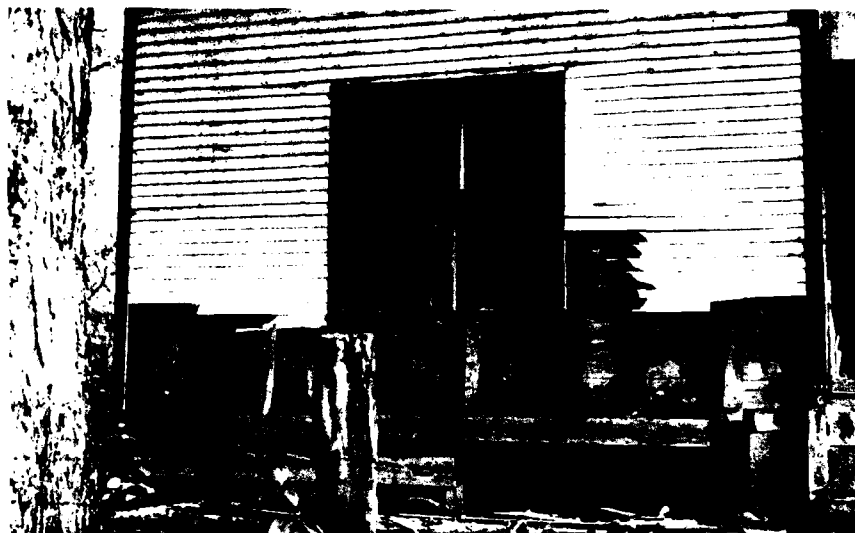
Fig. 54: Detail of log construction beneath framing in southwest wall of Building 1, Tract 411.

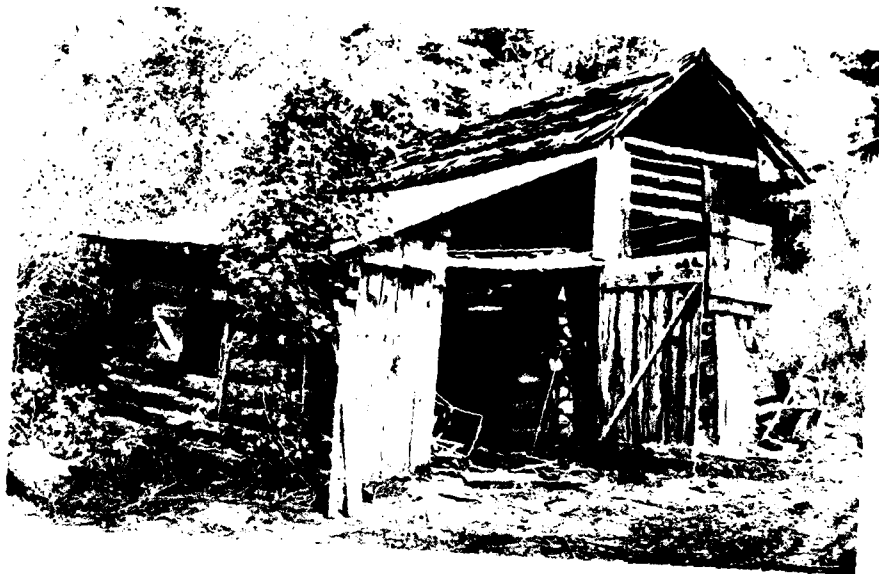
Fig. 56: General view of Building 2, Tract.411. Note shake roof.

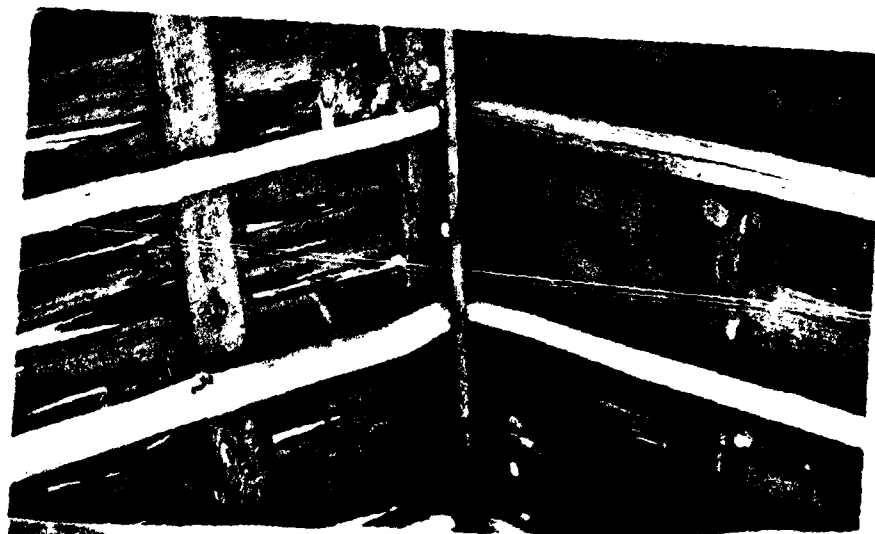
Fig. 57: Building 2, Tract 411. Detail of roofing construction. Note decorticated pole rafters and ridge board.

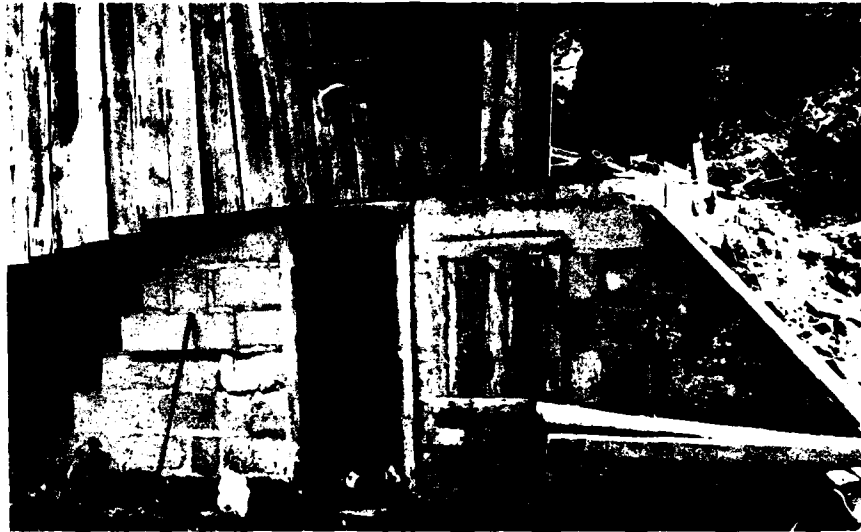
Fig. 58: Dressed sandstone cold cellar supporting Building 3 on Tract 411.

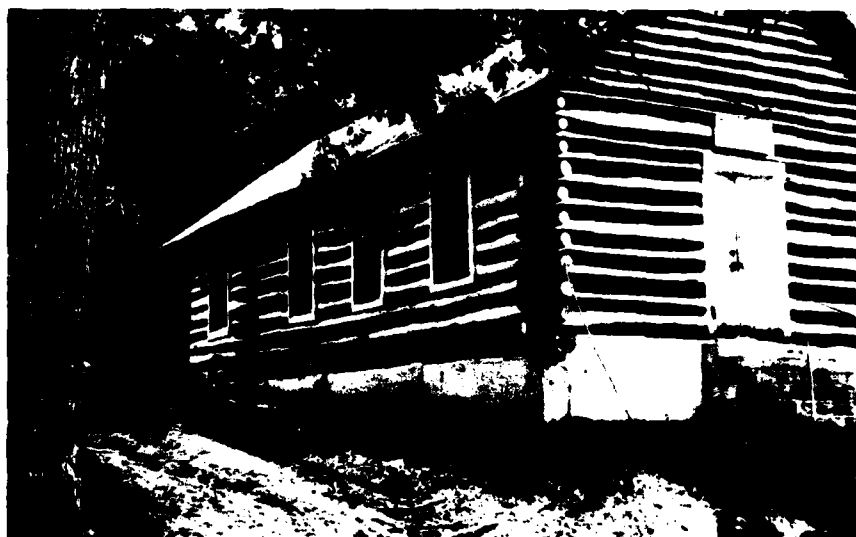
Fig. 64: The southeast and southwest walls of Carter Chapel. Note the log addition on the northwest side of the building.

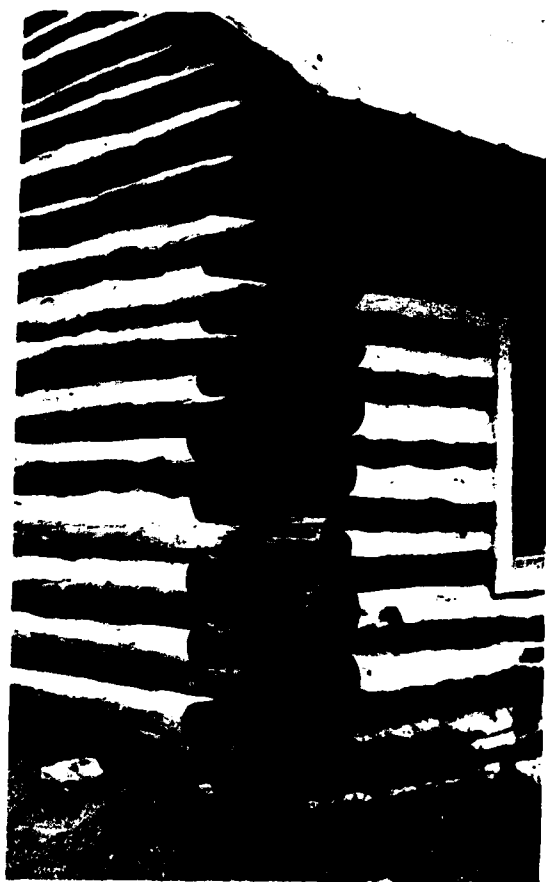
Fig.-67: Detail of saddle notching on logs of Carter Chapel.

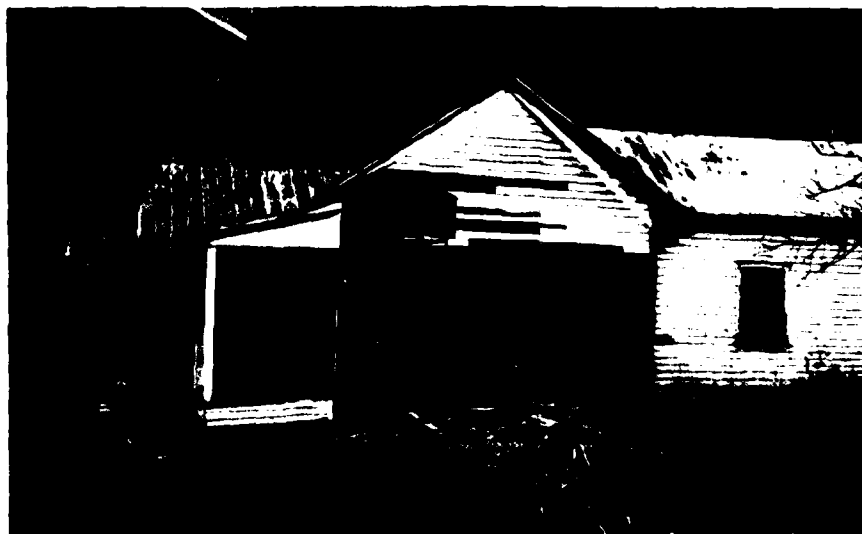
Fig. 74: Detail of log construction northwest wall of Building 1, Tract 921. This is the northeast side of the dwelling and is the main entrance. Logs have been matchmarked for dismantling and later reconstruction.

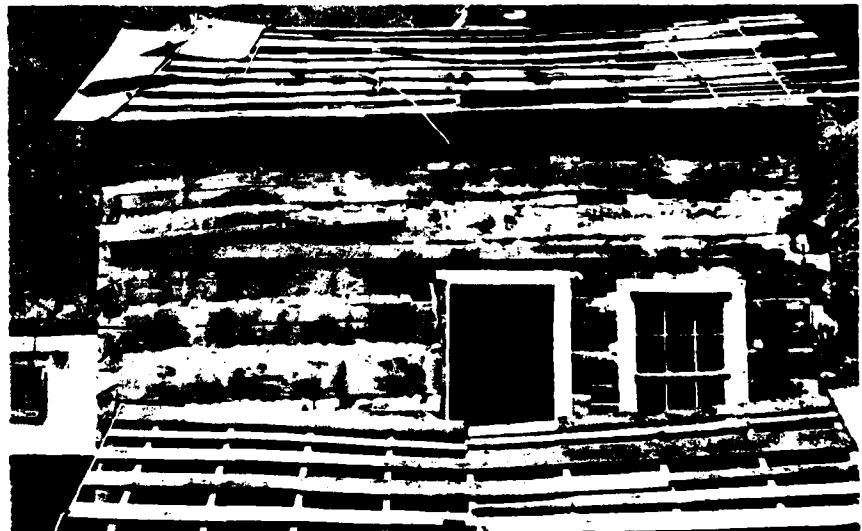
Fig. 91 : Northeast wall of log portion of dwelling on Tract 1014. Note collapsed porch roof.

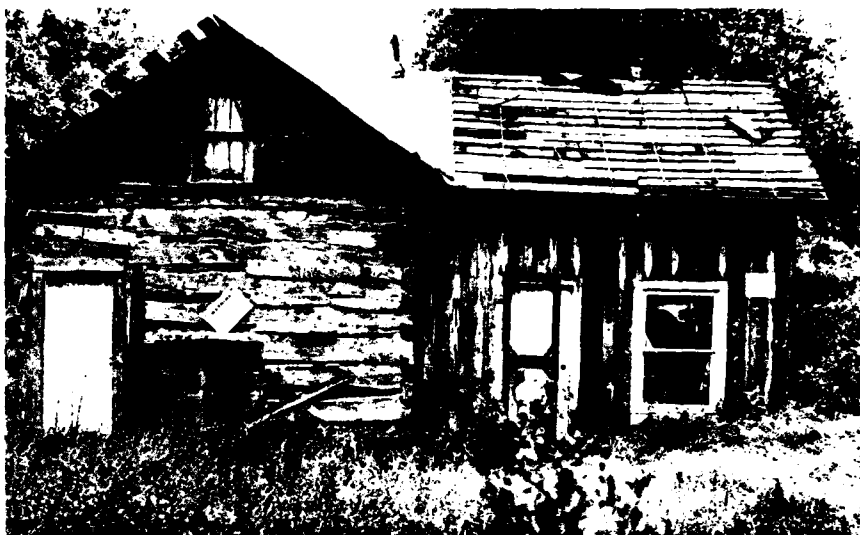
Fig. 92: Northwest wall of log portion of dwelling on Tract 1014. Note former chimney opening and use of riven weatherboards over interstices of some of the logs. Gable is assembled with cut nails.

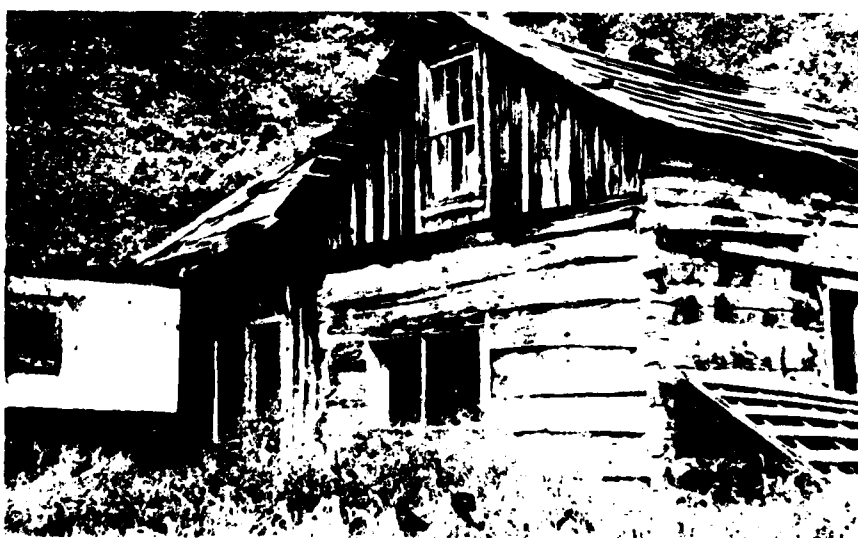
Fig. 93: Southeast wall of log portion of dwelling on Tract 1014. Contrast gable construction with that on opposing wall.

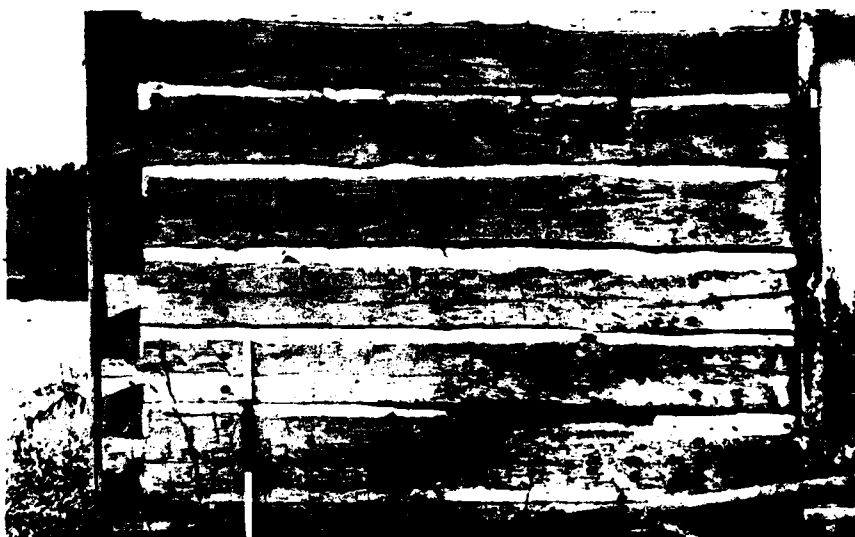
Fig. 102: Detail of auger holes on north face of eastern cabin at Horton/Kitchen home.

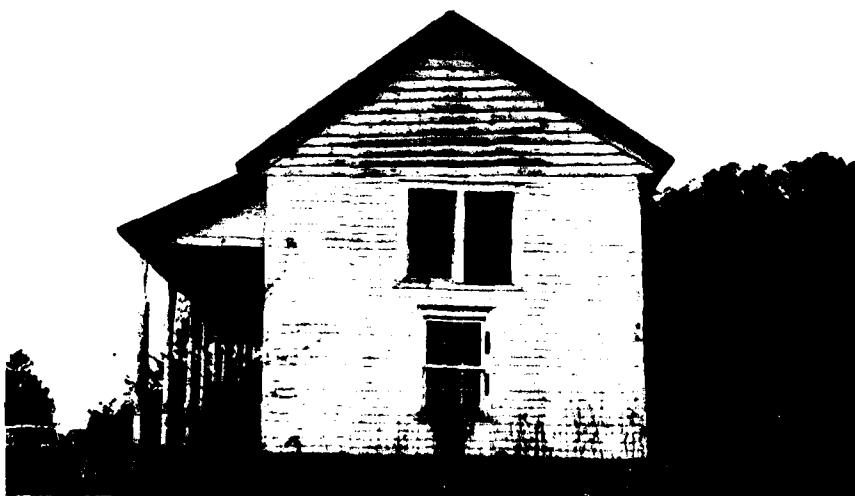
Fig.105: Eastern side of eastern cabin Horton/Kitchen home. Note  
 replacement upper windows and use of sawed clapboard  
 covering on wall.
